**GLACIAL LAKE
OUTBURST FLOOD
HAZARD
ASSESSMENT IN A
PART OF
UTTARAKHAND, INDIA**

AMIT ANAND
March, 2014

This thesis submitted to the Faculty of Geo-information Science and Earth Observation (ITC) of the University of Twente in partial fulfilment of the requirements for the degree of Master of Science in Geo-information Science and Earth Observation.

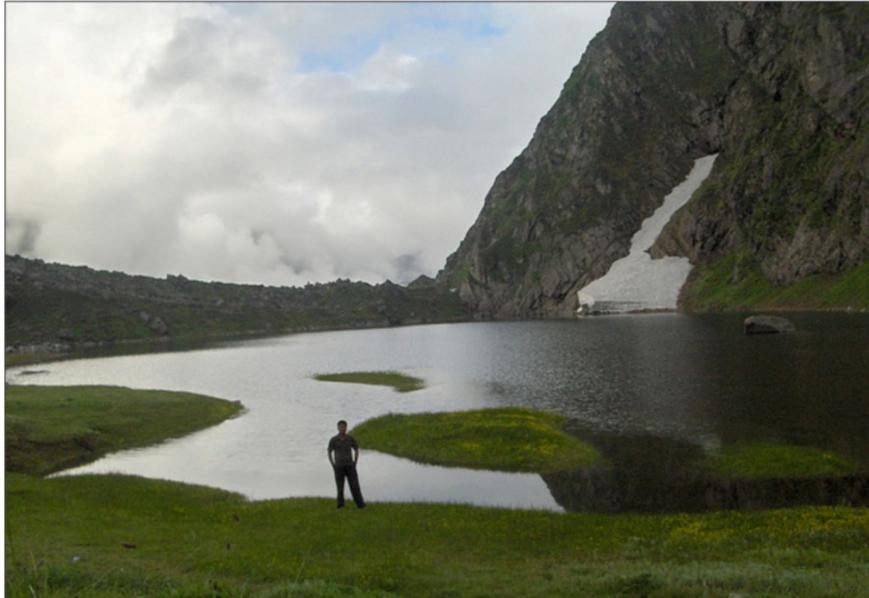
Figure 1: Chorabari lake before disaster (Source: Vadakayil A, 2013)

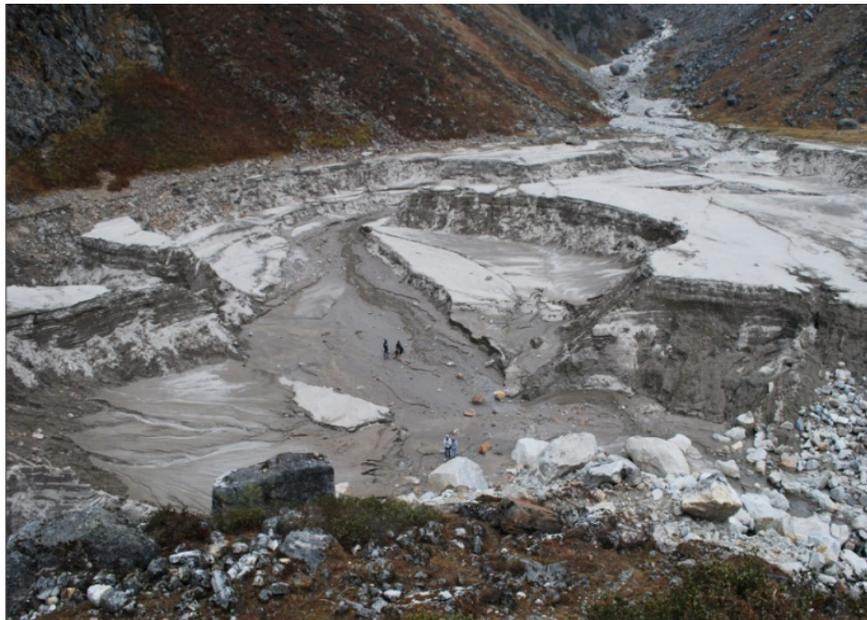
Figure 2: Chorabari lake after disaster (Field photograph)

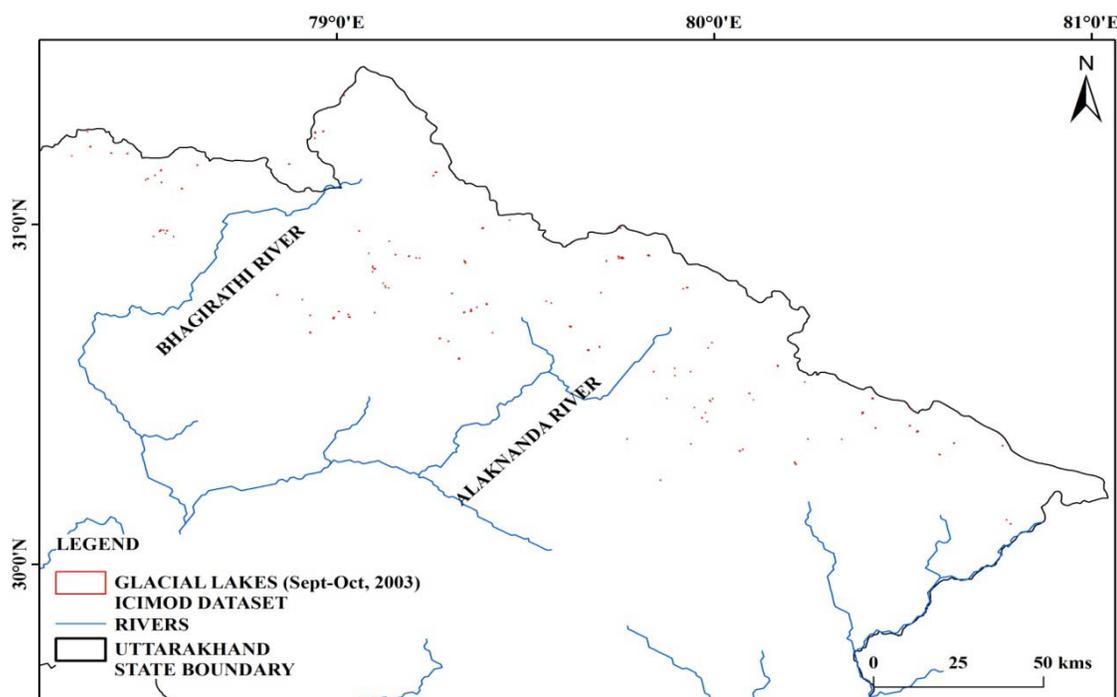
Figure 3: Mapped glacial lakes (Source: ICIMOD)

ICIMOD prepared an inventory (represented in Figure 3) for glacial lakes of Uttarakhand in 2005 using remote sensing dataset of 2003 and identified 127 glacial lakes in Uttarakhand. SAC Ahmadabad in 2011 also prepared the inventory for Uttarakhand glacial lakes using single year dataset and reported existence of 118 glacial lakes in the state. Other studies are also limited with either limited period dataset or complete Uttarakhand inventory preparation. The present study was carried out to make the inventory of glacial lakes of complete Uttarakhand region using 4 decade remote sensing datasets from 1972 to 2012 to understand more accurate numbers & areal extent at different altitude range and changes in the lakes in last 40 years. GLOF hazard assessment studies are still very limited for complete Uttarakhand region (represented in Figure 4)

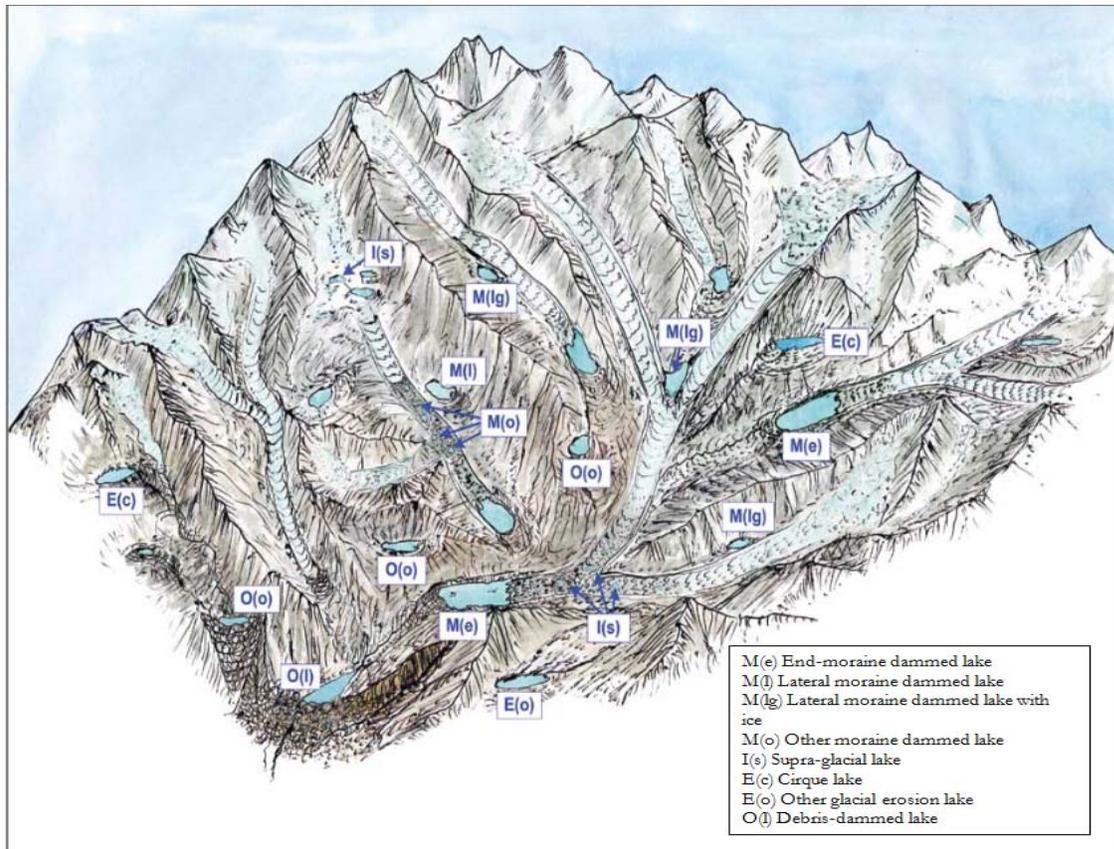
Figure 5: Types of glacial lakes (Source: ICIMOD)

- **Moraine-dammed lakes:** Due to thinning and retreat of glacier tongue, melt water gets accumulated in the depression between the glacier terminus and its end moraine and such lakes are termed as moraine-dammed lakes. Some lakes also accumulate between the lateral moraine and the valley side along the glacier margins. These lakes have high tendency of bursting as dams are physically weak and unstable and undergo various changes due to slope failures, slumping etc.

- **Erosion lakes:** Erosion lakes are glacial lakes that form due to past glacial erosion process and exist in depression of glacier retreat region. They exist as cirque glaciers or as glacial trough valley lakes. They exist for from hundreds or thousands of years.

- **Other glacial lakes:** Glacier valley floors receive masses from rock falls, debris flows or landslides, damming local streams of glaciers. Such lakes are called as other glacial lakes.

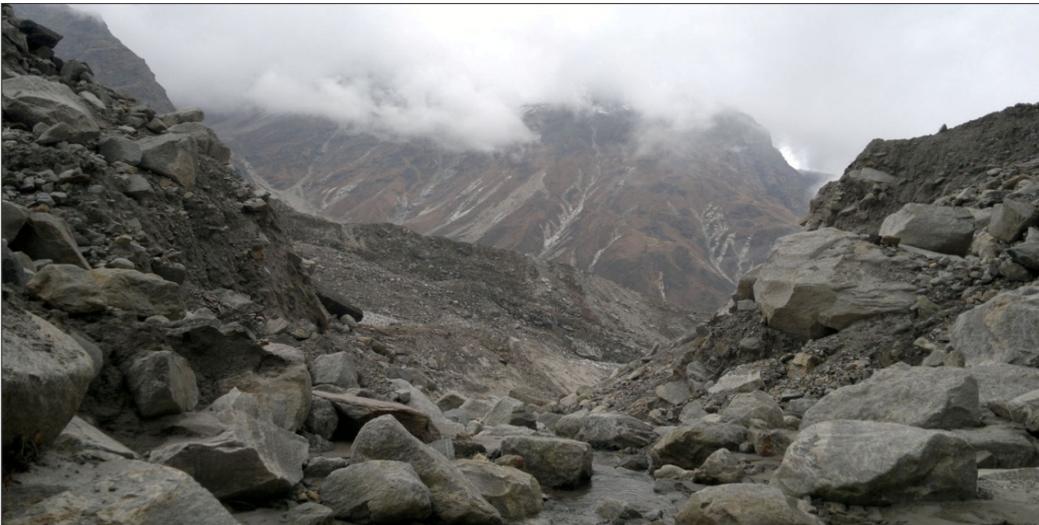
Figure 8: Breaching point of Chorabari lake (18th Oct., 2013)

The initial crest level (3855 m) and bottom level (3814 m) was measured using DGPS in the field and the initial crest width (56 m) and the bottom width (5 m) was measured from LASER Distance Finder (LDF). Crest length was measured 22 m during the field survey. Erosion based failure was considered and the upstream slope value of 0.76 was calculated using breach length and depth ratio. Top width of breach (46 m) was measured using LDF. The area of lake was calculated using LISS 4 high resolution Imagery and the mean depth of lake was measured using staff guage. Finally the volume was calculated using formula area* depth.

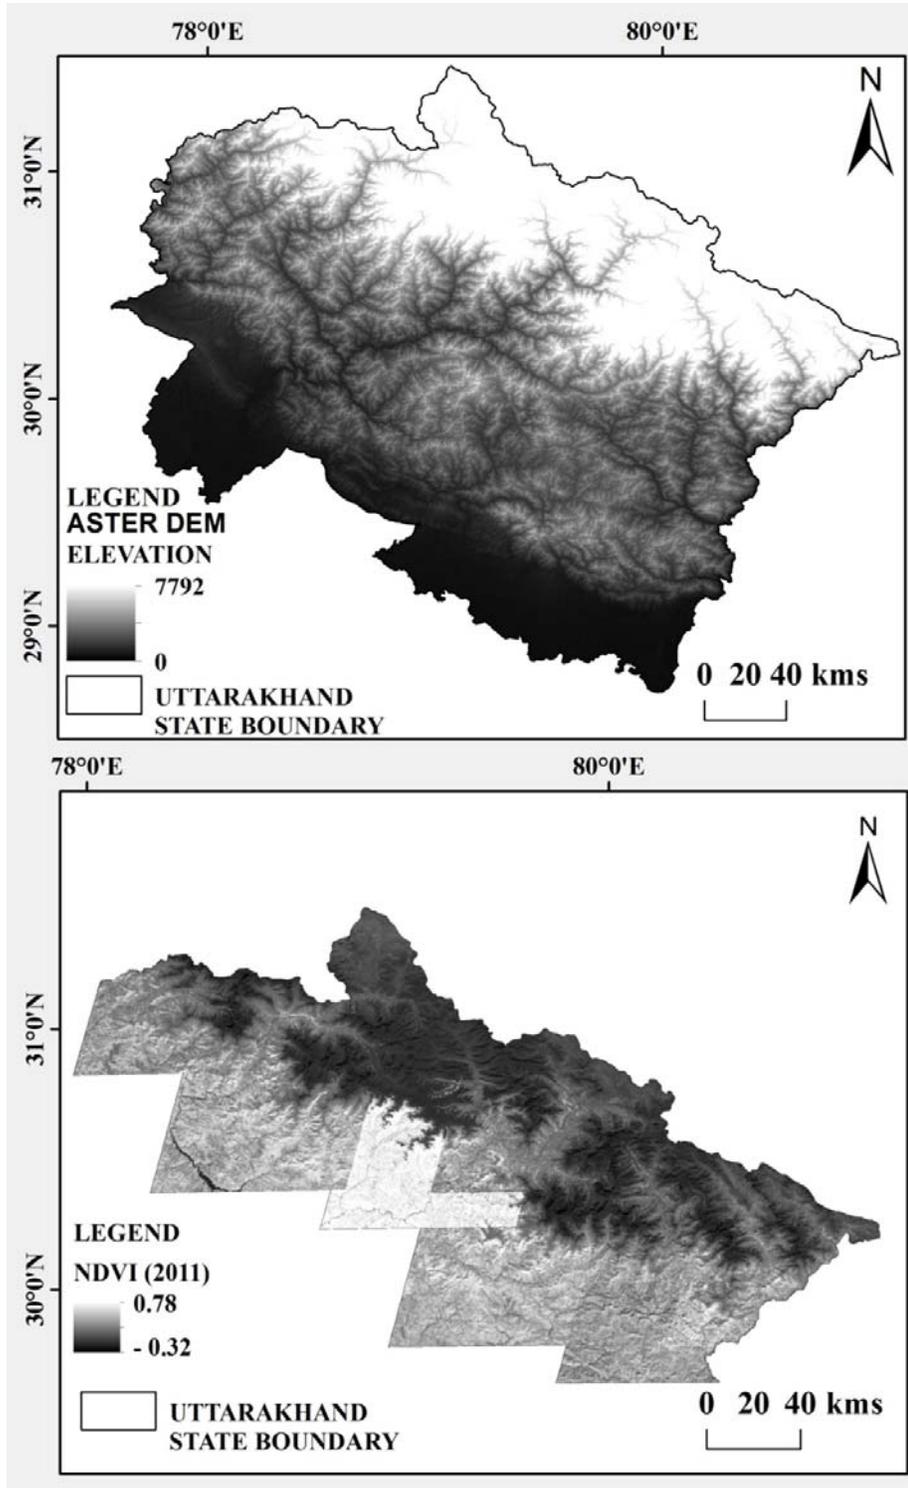
Figure 12: ASTER GDEM and NDVI Image of LISS IV of study area

LISS 4 image of 18 Nov 2011 and Cartosat 1 DEM with 10 m vertical accuracy, provided by IIRS were used for Chorabari lake volume calculation and Mandakini river channel digitization. ICIMOD shape files and Google Earth were referred for glacial lakes mapping. ASTER GDEM of Uttarakhand and the NDVI image of LISS IV used for the study is represented in Figure 12.

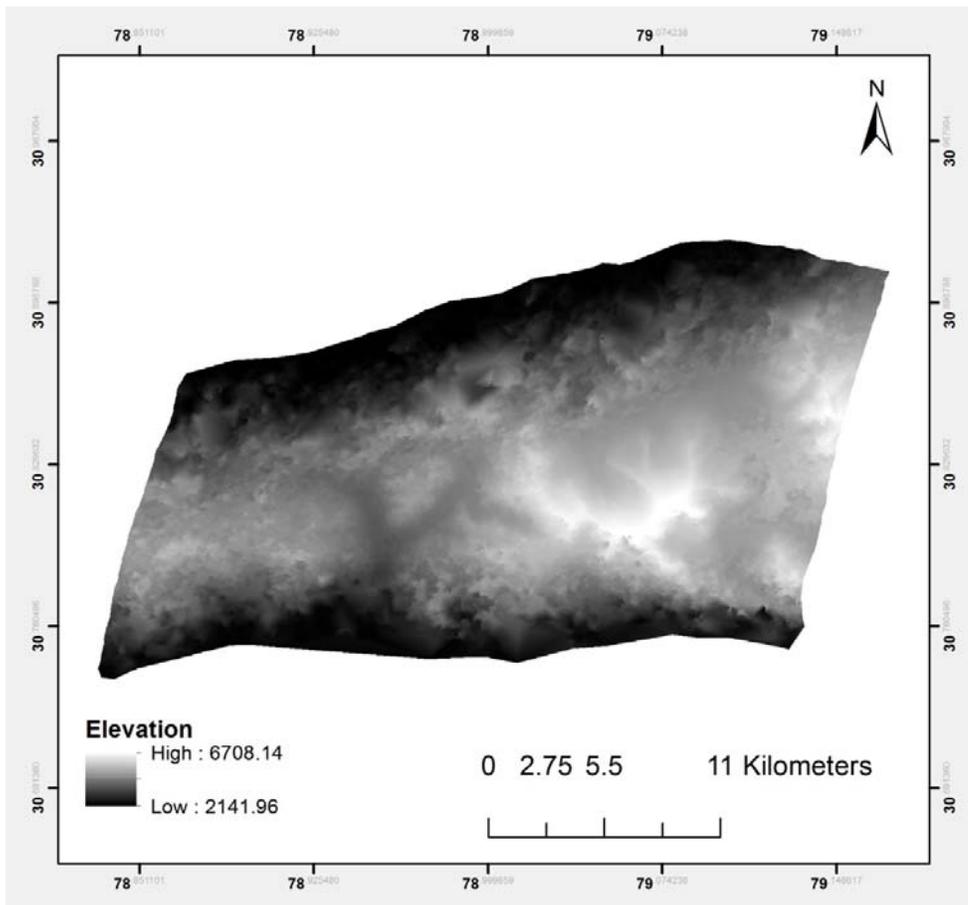
Figure 13: DEM generated from stereo pair of Cartosat-1

For identifying the glacial lakes, good quality DEM is required for calculating some parameters such as minimum, maximum and mean elevation, slope etc. No local or national DEM of reasonable quality were available for the study area. Generating the DEM by digitizing the contours of toposheet was not possible due to toposheet unavailability (as the study area comes under restricted zone). Cartosat-1 stereo pair generated DEM was also analysed and was not found to be of good quality because of insufficient height information of the area and unclear features. Therefore ASTER GDEM version 2 was used for the study as the best available option. The vertical accuracy of ASTER GDEM is within -0.2 m on average, with an accuracy of 17 m at the 95% confidence level (ASTER GDEM Validation Team, 2011). Figure 13 represents the DEM generated from stereo pairs of Cartosat-1 data using ERDAS LPS module.

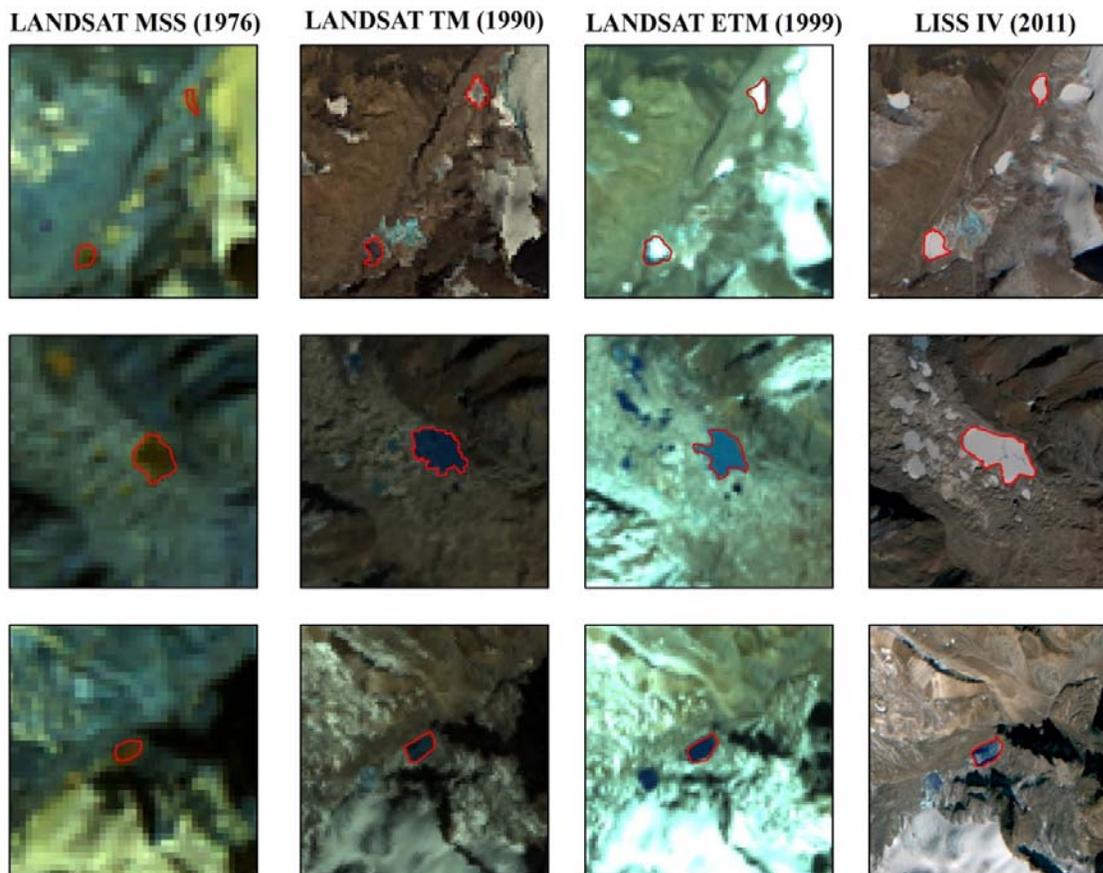
Figure 14: Glacial lake mapping (1976-2011)

Although glacial lakes can be identified if it contains at least one pure pixel and is perfectly aligned with the raster grid, but generally they are not aligned with the raster grid. Therefore, the smallest lake that can be identified is 2X2 pixel. But 3X3 pixel is chosen to detect even the mixed pixels that contain majority of lakes (Quincey et al. 2006). The smallest glacial lake area that could be mapped in LANDSAT MSS is of area 0.03 km². In TM and ETM+ 0.01 km² area could be mapped and in LISS 4 minimum of 0.0004 km² area could be mapped. A threshold of 0.01km² was decided to map the glacial lakes of all the imagery, as lake below this threshold does not contain substantial water. In this study, error in image co-registration did not play a significant role, since comparison is not made pixel by pixel but feature to feature.

Due to spectral reflection, shadowed areas get misclassified as lakes which can be found with the help of DEM. According to literature, glacial lakes mostly exist in the areas where slope is less than 10 degree. Therefore, in order to avoid the misclassification of shadow to lakes, ASTER DEM was used in the study. Buffer of 100 m was created around the unclassified area and the mean slope of the buffer zone was calculated considering the relative vertical accuracy of GDEM which is around 20 m. The calculated slope and NDVI, NDWI threshold range were then used to verify the area. Fully frozen lakes have not been reported in the study. Figure 14 represents the glacial lake mapping from various datasets of 1976 to 2011.

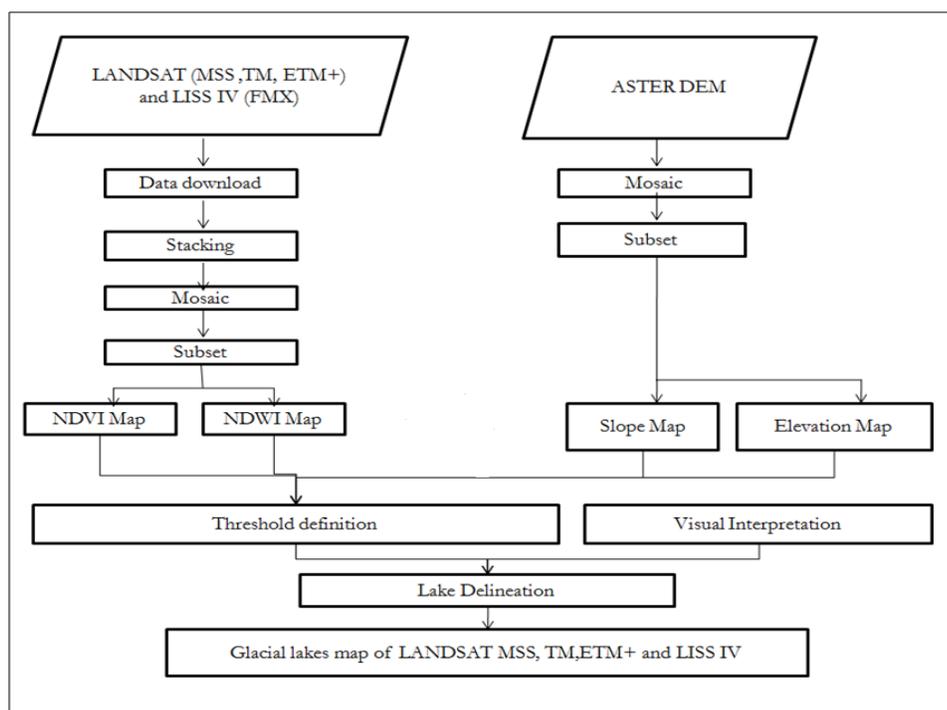
Figure 15: Methodology for objective 1

Overview of methodology adopted for achieving objective 1 is represented in Figure 15

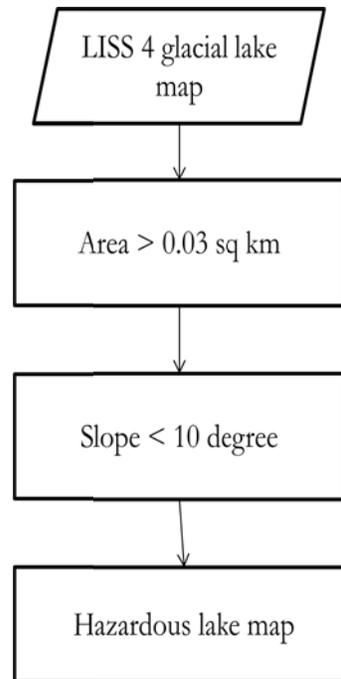
Figure 16: Methodology for objective 2

To carry out the hazard assessment, minimum lake area threshold was defined considering the area of Chorabari lake in the study. The slope of maximum 10 degree was considered as another parameter for the hazard assessment because lakes with lower slope value have more chances to grow. Following methodologies were adopted to carry out objective 2 i.e. Hazard assessment of lakes;

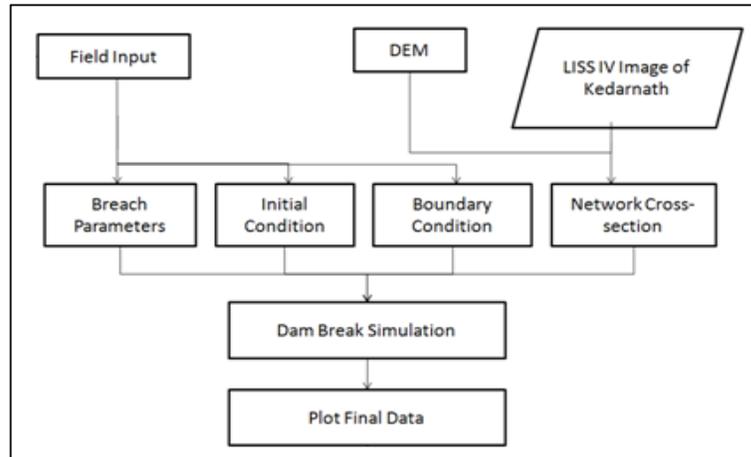
Figure 17: Methodology for objective 3

Methodology adopted for achieving Objective 3 has been depicted in Figure 17

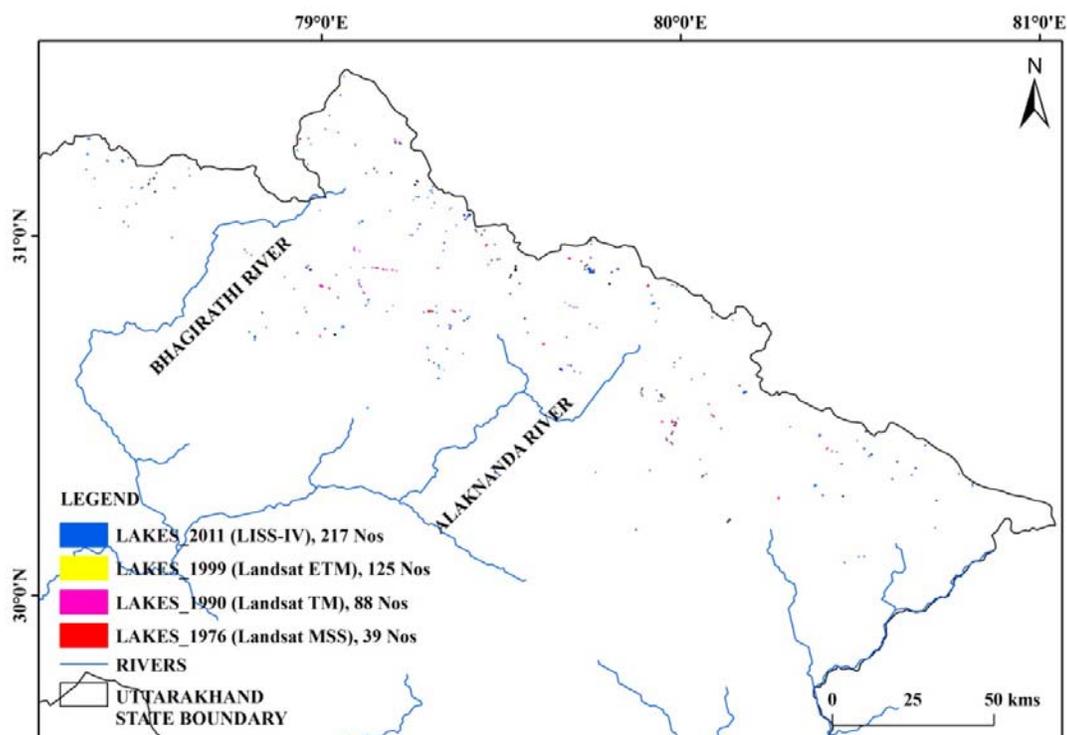
Figure 18 represents the mapped glacial lakes from LANDSAT MSS to LISS IV. The generated database was found to be of reasonable accuracy.

Figure 18: Mapped glacial lakes

The total area of the lakes varied from 0.85 sq km to 3.36 sq km in years 1976 to 2012. The total lake volume of 21.66 M cubic metres was calculated in the year 1976 which increased up to 90.34 M cubic metres in 2011. Comparison based on the number of lakes present in the time series yielded the following result. In the year 1976, a total of 24 lakes were present, in 1990 the number increased to 42, in 1999 total count of lakes was 67 and in 2011 total lakes were 93. All the mentioned lakes are of area greater than 0.01 km sq.

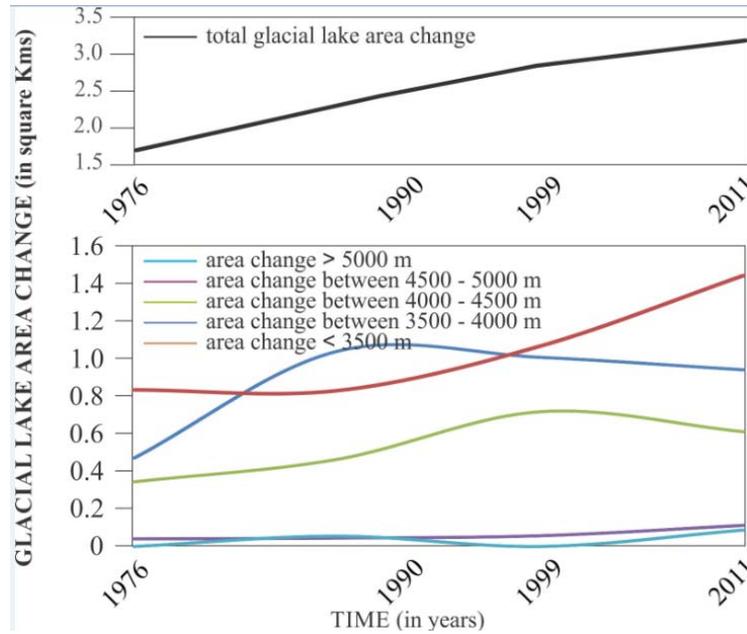
Figure 19: Change in area of lakes with elevation

The altitude variation of glacial lakes' area has been represented in Figure 19 considering the total mapped lakes and it was found that 3500-4000 m elevation zone is maximum sensitive for lake change. Number of lakes represented in Figure 20 illustrates decade wise analysis and it was found that highest number of lakes was found in the zone 3500-4000 m.

The most marked increase in the lake area and number was observed in the altitude range of 3500-4000m while very less variation was seen in the range more than 5000m.

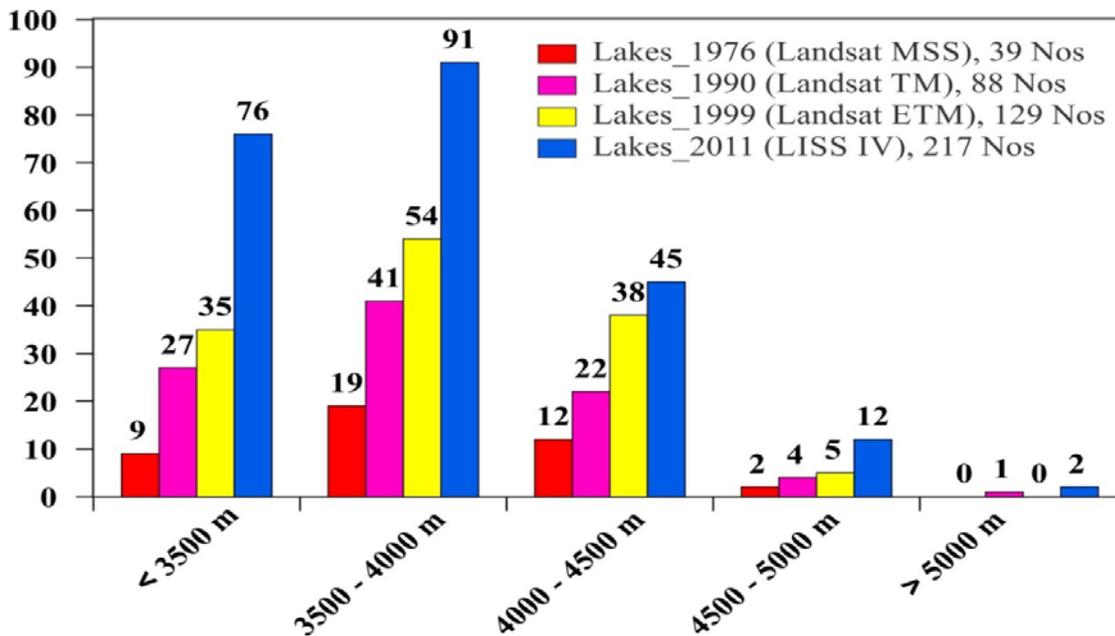
Figure 20: Distribution frequency of glacial lakes in different elevation bands

The analysis involves selection of the most sensitive altitude zone for glacial lakes on the basis change in area. A strong topographic control has been found on the distribution pattern of the glacial lakes in the given region. In this regards most of the glacial lakes are found to be concentrated within an elevation band of 3500 m to 4000 m.

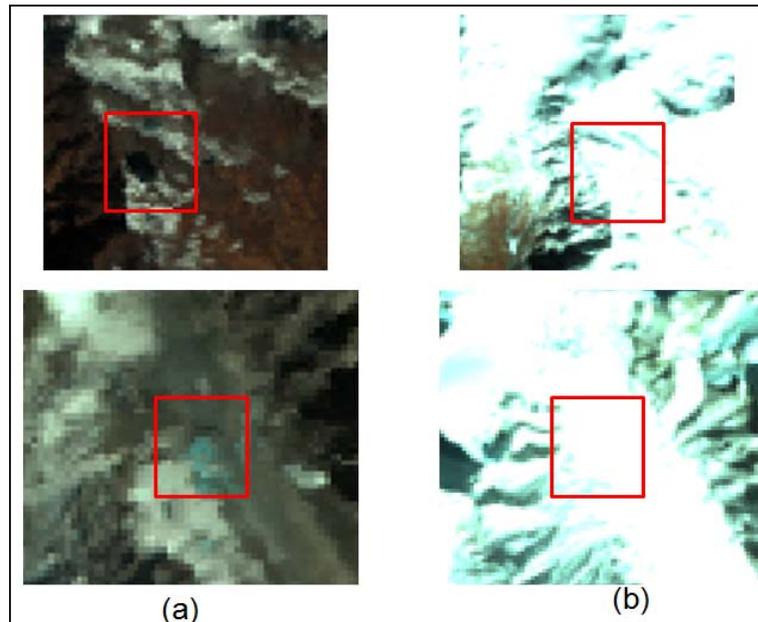
Figure 23: Disappearance of lakes in TM and ETM+

From 1976 to 2011 there has been an increase of 69 lakes having area more than 0.01 sq km. 18 new lakes grown in 1990 where as this number increased to 29 in 1999 and 31 new lakes were found in LISS 4 imagery of 2011. Very less disappearance of lakes were observed in last 40 years of datasets.

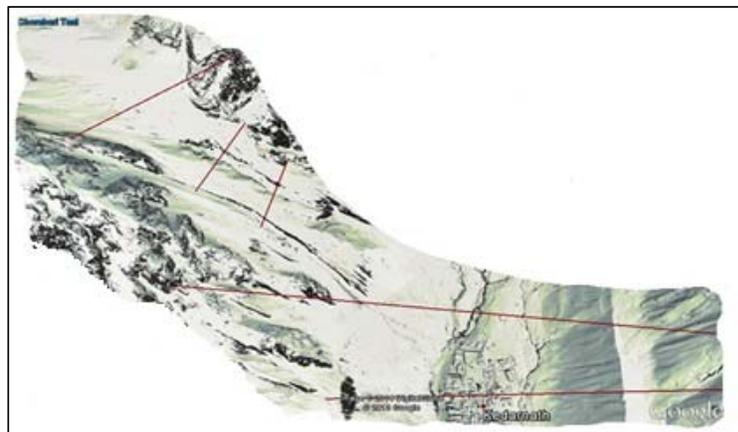
Figure 24: Cross-section representing trajectory of GLOF from Chorabari lake to Kedarnath temple (Source : Google Earth)

The GLOF simulation was carried out for Chorabari lake breach. The resulting dam breach flood was routed through Mandakini River channel flowing just downstream of the lake. River channel has been represented in the model by cross-sections derived from high resolution Cartosat-1 DEM provided by IIRS with vertical accuracy of 10 m. Cross-sections interval has been taken as per the field readings. The altitude of the Chorabari lake measured in the field was 3855 m and volume of the lake was calculated using Equation 6 which comes out to be 0.65 Mm³. Figure 24 represents the cross section of GLOF trajectory.

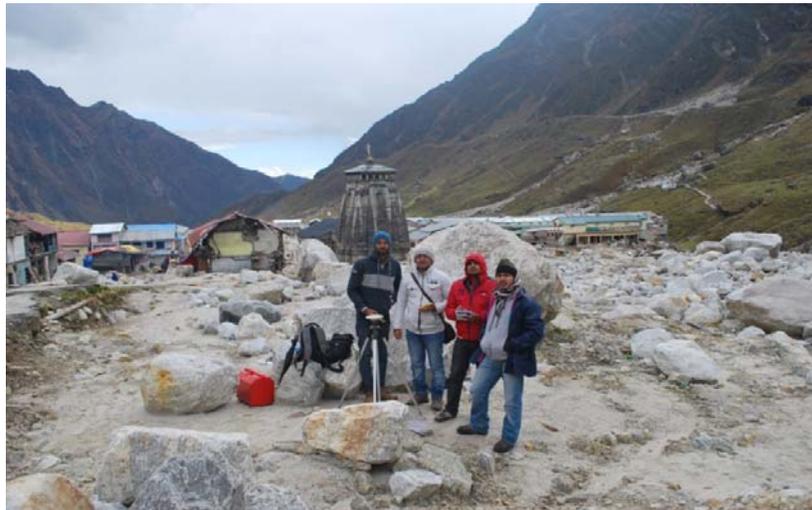
Figure 25: Area representing cross-section point (1800m downstream of Chorabari lake)

The water level change at temple site (at 1800 m d/s of lake) was approximately 2.5m and at 836 m d/s of lake it is about 7m, which was similar to what was observed in post flood field survey at Kedarnath temple situated next to the Mandakini river channel.

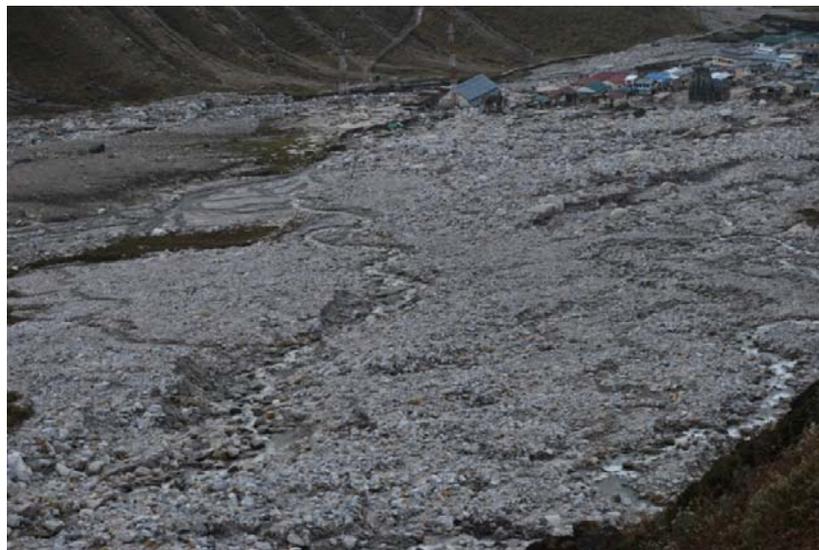
Figure 26: Area representing cross-section point (800m downstream of Chorabari lake)

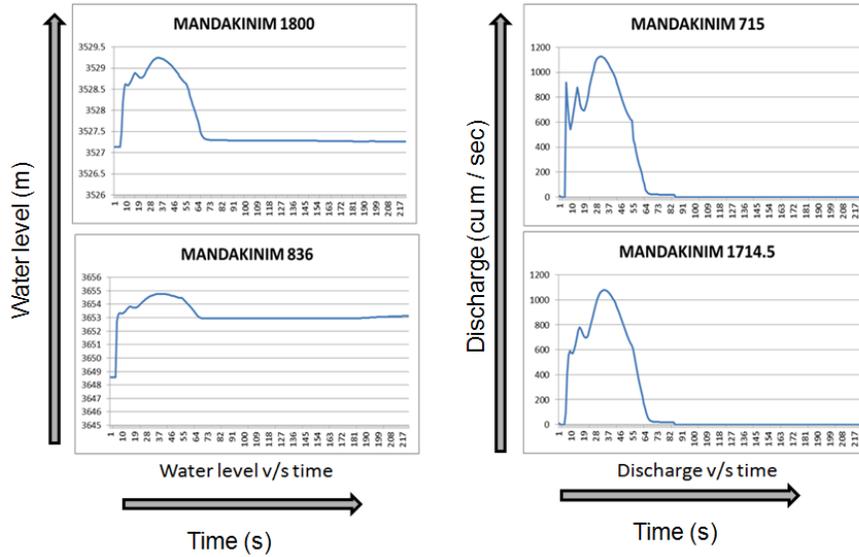
along with other parameters given above was used for simulating flood discharge considering erosion based overtopping of Chorabari lake. The peak discharge of 1127 m³/s and 1080 m³/s was estimated at site 715 m and 1714.5 d/s of lake. The site at 1714.5 is near Kedarnath temple. This discharge corresponds to approximately the volume of 0.65 M m³ of water.

Figure 27: water and discharge v/s time

The 1-D hydrodynamic simulation was done for the Chorabari lake. The resulted hydrograph in erosion based module shows that entire lake breached in 10-12 minutes after initial breach by overtopping (Figure 27). Figure 25 and 26 represent the cross-section locations at 1800m and 800 m downstream lake, respectively. The initial and final width of breach as measured in the field was taken as 56m and 5m respectively. The side slope was calculated as 0.76 using breach length and depth ratio.

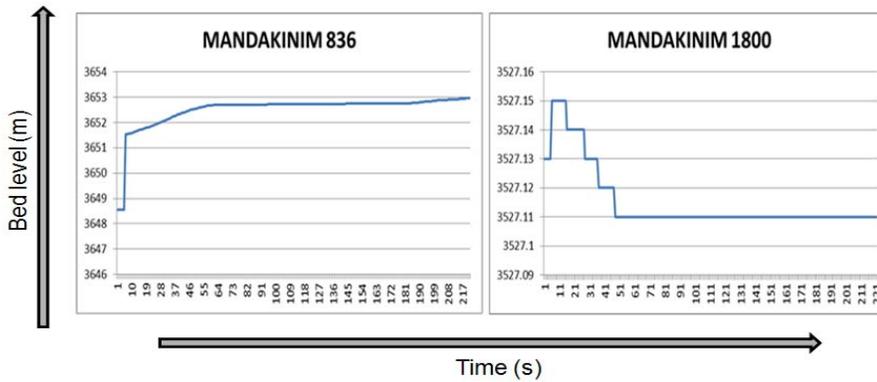
Figure 28: Bed level v/s time

The Smart and Jaeggi (1983) presented a sediment transport formula which calculates the transport of coarse sediments in steep channels/rivers. This method is used here in Mike 11 HD sediment transport model Figure 28. This method was used to model the sediment transport as well update the bed level of rivers due to erosion and deposition of sediments during GLOF event. The river bed level increased by 5 m at 836m and decreased by 0.05m at 1800m. This result does not match with field observations. During field survey the bed level increase of 2m and higher was seen upto and at Kedarnath temple. It was found during interview with locals in field, that there was one major flood event on 16 June 2013 evening, in which major back part of Temple area was totally washed out and lot of debris got deposited. But this event could not be simulated in present study, as river cross-sections are available for before flood event, derived from NRSC's cartosat-1 DEM of 10 m resolution.

Overall flood water level and discharge matched with the ground observations, but mismatch was found between the bed level changes due to sediment transport model. Therefore more field data is required on depth and size distribution of sediments of study area downstream of lake. As area surrounding Kedarnath temple was highly developed in term of number of hotels and civil infrastructure, the roughness value of this area need to be relooked along with high resolution DEM of area so that better simulation of floods as well as sediment transport can be done in future studies.

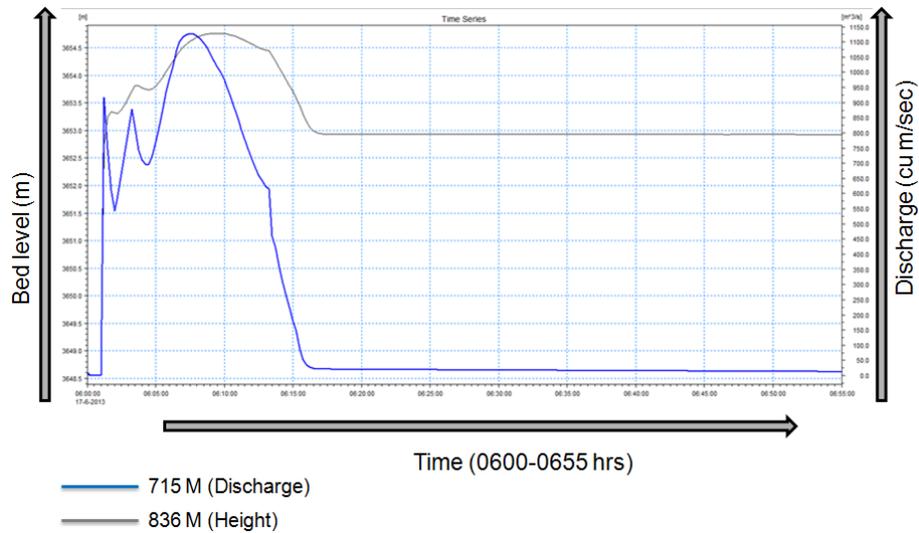
Figure 29 represents the height and discharge at 836 and 715 m downstream the lake, respectively as MIKE 11 gives discharge and height at two different points.

Figure 29: Bed level and discharge at 836 m and 715 m downstream of lake
